MEP Conditions Assessment - DRAFT

City of Middleton

MIDDC 179714 | September 23, 2024

Conditions Assessment - DRAFT

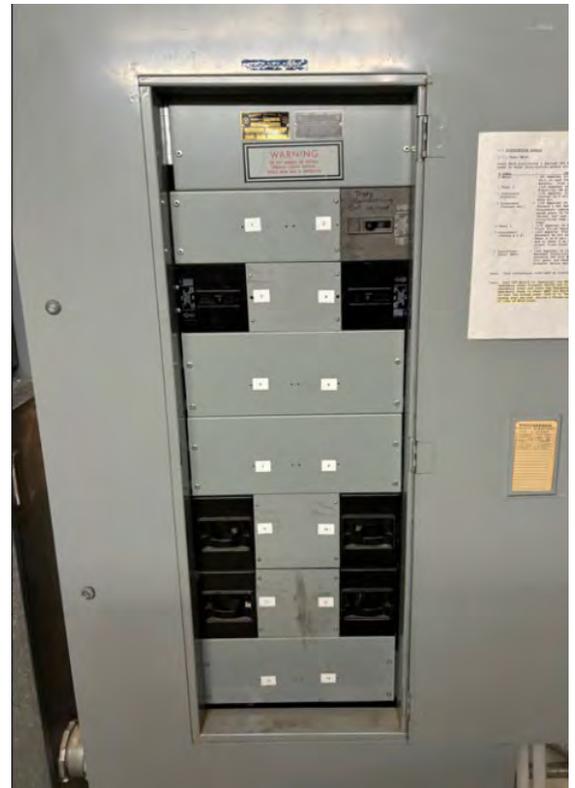
- The 600A service disconnect and main switchboard are beyond expected service life, and the condition is fair to poor. Availability of replacement breaker may become limited.
- The electric revenue meter is located between the service disconnect and main switchboard. This configuration does not meet current standards.
- The panelboards are beyond the expected service life and are in fair to poor condition with the exception of Panelboard A.
- Panelboard A was replaced in 2002 and is in good condition.

- Reconfigure electrical service to current MG&E standards. Meter and CT cabinet should be installed between the electric utility service transformer and the service disconnect or switchboard.
- Replace 600A service disconnect and 600A main switchboard with a 600A panelboard with main breaker to serve as the service disconnect.
- Replace all panelboards with the exception of Panelboard A.
- Evaluate if Panelboard A should be replaced as part of overall electrical replacement program.
- As the main switchboard and panelboards are replaced, determine the best location for potential solar PV generation tie in points. Solar PV influences the required ratings of electrical power distribution equipment.

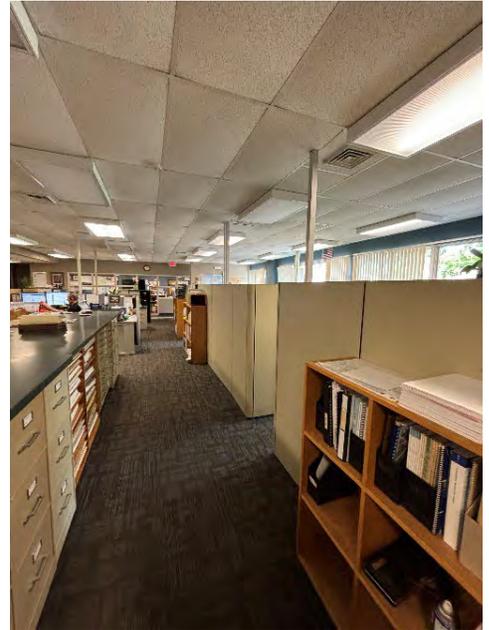
- Lighting fixtures appear to be in satisfactory condition.
- Overall, light levels were adequate.

- Upgrade non-LED lighting.
- Evaluate individual areas to develop requirements for temperature/color of light and dimming needs.
- Consider performing a photometric evaluation to determine if certain areas could benefit from reconfiguration of fixture locations rather than direct fixture replacement.
- In conjunction with lighting upgrades, add receptacles to current codes at a minimum. Interview staff to identify additional location as needed.
- Utilize Focus on Energy for energy efficiency incentives.

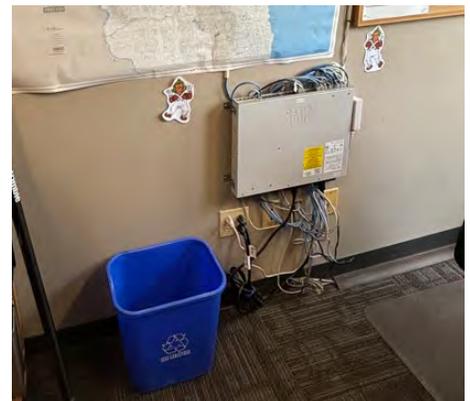
Security camera coverage need improvement. Networking infrastructure is adequate. Several network switches are in office spaces. Some network and security infrastructure lacks dedicated, secured space. Conference rooms and the Council Chambers have a mix to technology solutions.

- Relocate network and security infrastructure and allocate dedicated, secure rooms.
- Evaluate equipment age to balance replacement over relocation.
- Relocate and segregate low voltage and power wiring into different raceways.
- Upgrade older technology solutions in conference rooms to match most recent conference room implementation.
- Evaluate and reconfigure technology solutions in Council Chambers to be more accommodating for the public seating in the space.
- Evaluate additional security camera coverage in addition to the public facing front entrance and desk area.

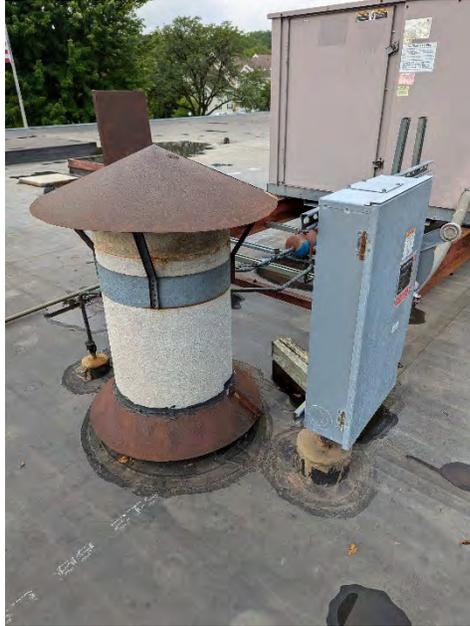
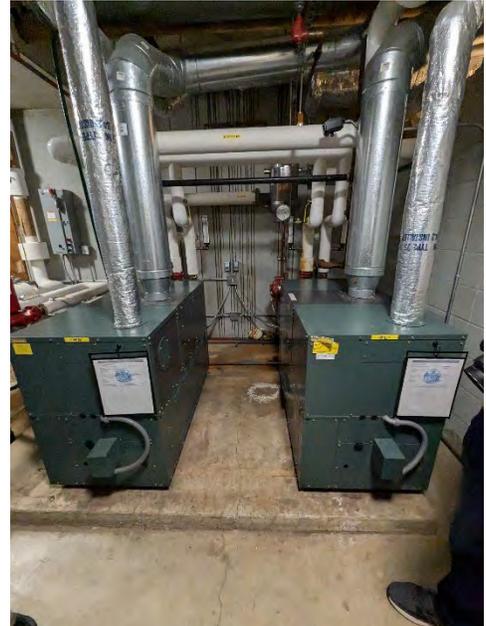
2.1.2.1 Boilers, B-1 & B-2

- Boilers appears to be in satisfactory condition and work as designed according to staff but are past their expected service life.

- Level 1
 - Replace existing boilers, pumps, and accessories. Provide new high efficiency condensing boilers, pumps, and accessories in the same configuration as the existing system.
- Level 2
 - Remove boilers, associated pumps, controls and piping.
 - Provide new air-cooled heat pump air handling units to fully electrify the HVAC system, utilizing the PV Solar panels on site.
 - New DDC controls shall be compatible with campus wide control system.
- Level 3
 - Remove boilers, associated pumps, controls and piping.
 - Provide new geothermal vertical ground loop on site.
 - Provide new water cooled heat pump air handling units to fully electrify the HVAC system, utilizing the PV Solar panels on site.
 - New DDC controls shall be compatible with campus wide control system.

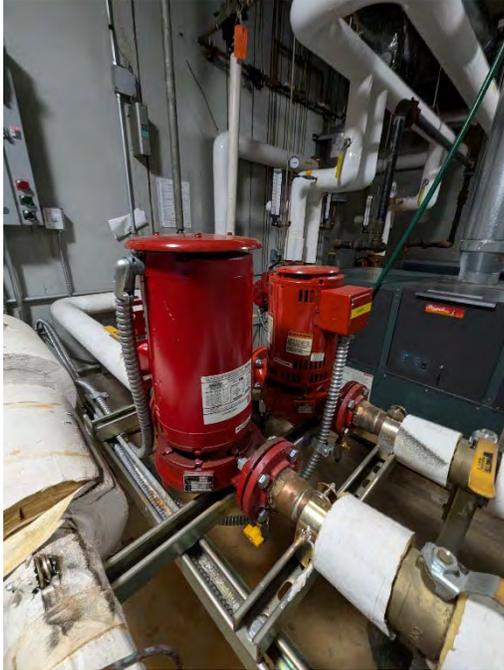
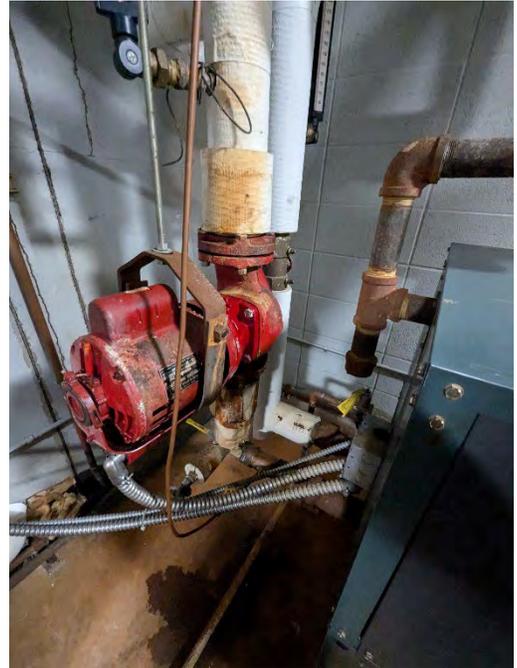
2.1.2.2 System Pumps P-3, P-4 and Boiler Circulating Pumps P-1, P-1

- System Pumps P-3 and P-4 appear to be in good condition.
- Boiler Pumps appear to be in good condition but display a moderate level of corrosion.
- Pumps do not include VFD modulating. System is configured for constant flow.

- Level 1
 - Existing system pumps P-3, P-4, and accessories to remain.
 - Remove existing boiler circulating pumps P-1 and P-2 and replace with new pumps to match new condensing boiler flow and pressure requirements.
- Level 2
 - Remove boilers, associated pumps, controls and piping.
 - No hydronic pumps required for Level 2 recommendation (air cooled heat pumps)
- Level 3
 - Remove boilers, associated pumps, controls and piping.
 - Provide new geothermal vertical ground loop on site.
 - Provide new glycol pumps, piping, valves, accessories, and controls for new geothermal system.
 - New DDC controls shall be compatible with campus wide control system.

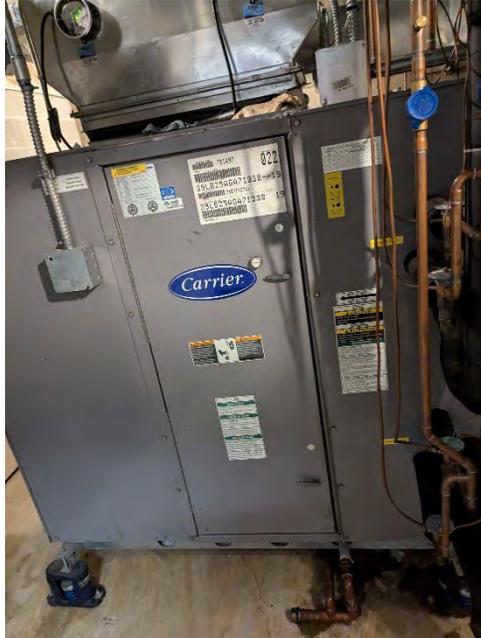
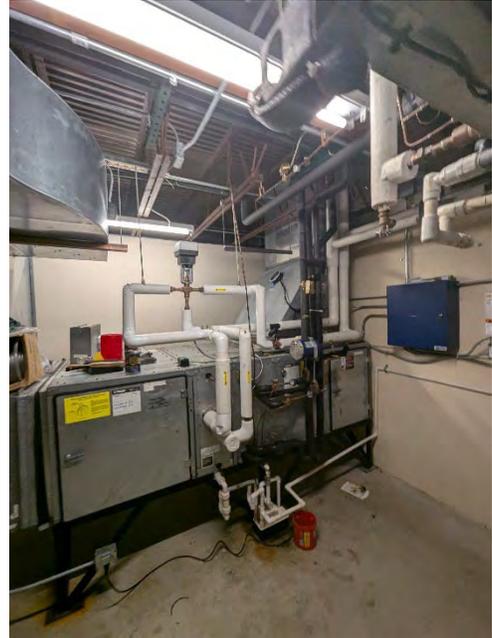
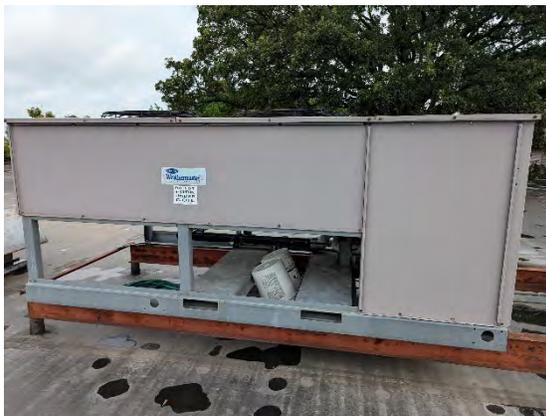
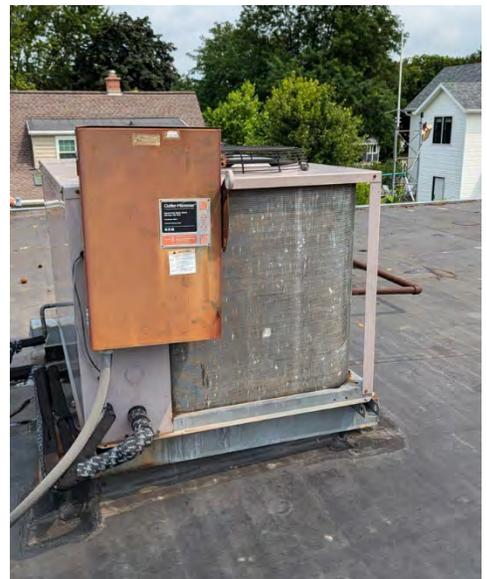
2.1.2.3 Air Handling Units; AHU-1 & CU-1 and AHU-2 & CU-2

- Both units appear to be in fair condition but are past their expected service life.

- Level 1
 - Remove existing air handling units and air-cooled condensing unit.
 - Provide new higher efficiency variable volume air handling units.
 - Existing ductwork to be cleaned.

- Level 2
 - Remove existing air handling units and air-cooled condensing units.
 - Provide new air cooled heat pump fan coil units. The units will be part of a VRF system with heat recovery. Enough new fan coil units will be provided such that there will be more temperature control zones than currently exist in the building.

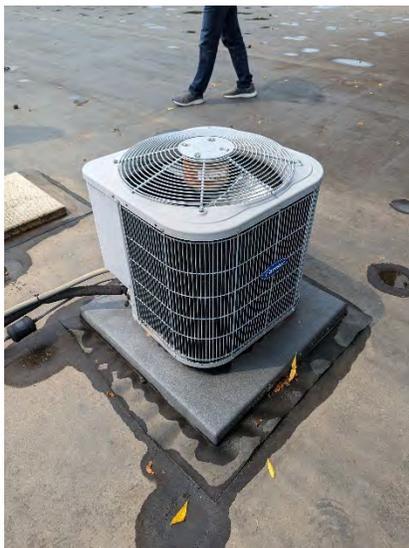
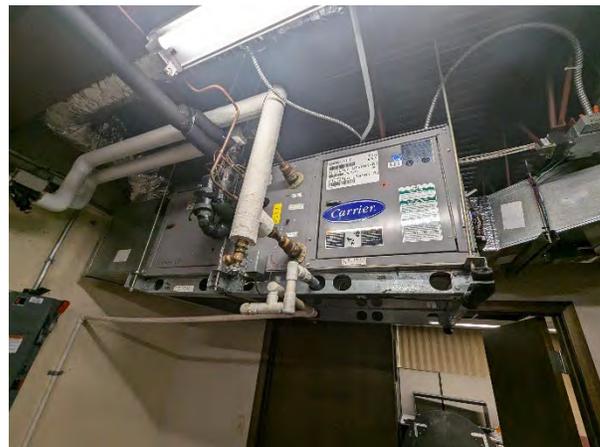
2.1.2.4 Fan Coil Unit & Remote Condenser, FC-1 & CU-2

- The unit appears to be in fair condition but is past its expected service life.

- Level 1
 - Remove existing fan coil unit and air-cooled condensing unit.
 - Provide new higher efficiency fan coil unit with DX cooling and remote air cooled condensing unit.

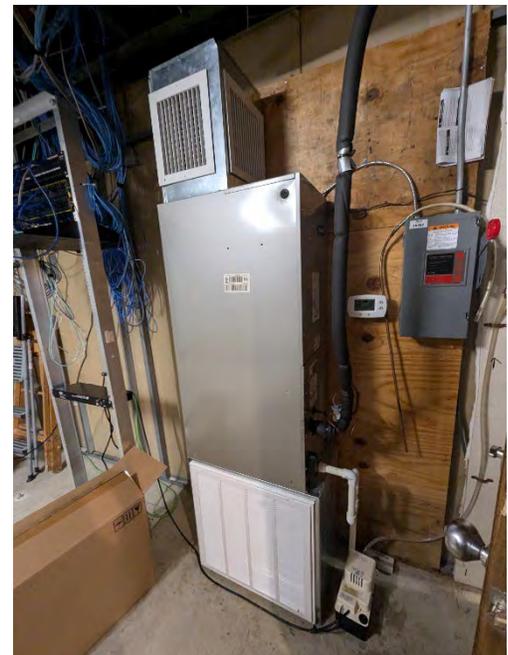
- The unit appears to be in good condition and appears to have several years of service life remaining.

- Level 1
 - Existing fan coil unit and air-cooled condensing unit to remain.
 - Existing ductwork to be cleaned and filter replaced.
- Level 2
 - Remove existing fan coil unit and air-cooled condensing unit.
 - Provide new air-cooled heat pump fan coil unit as part of a VRF system with heat recovery.
 - New DDC controls shall be compatible with campus wide control system.
- Level 3
 - Remove existing fan coil unit, air-cooled condensing unit, and associated heating coil.
 - Provide new cooling and heating water to water heat pumps located in the mechanical room with four pipe fan coil units at the zone level. Enough new fan coil units will be provided such that there will be more temperature control zones than currently exist in the building.

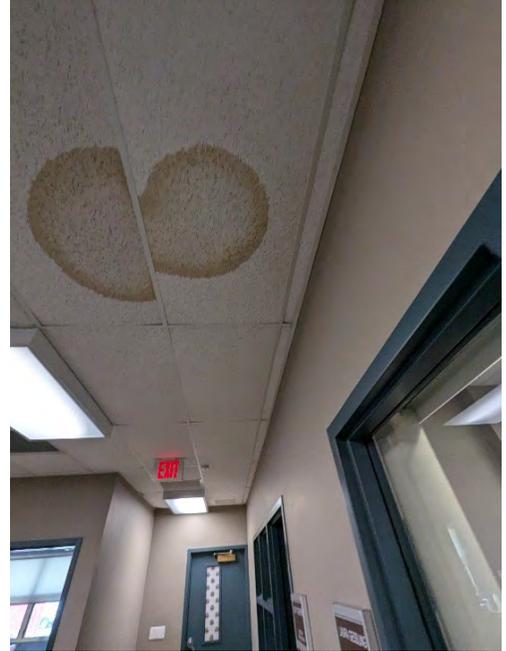
2.1.2.7 Variable Air Volume, VAV Boxes

- These units appear to be in fair condition but are nearing the end of their expected service life.
- VAVs are equipped with two-way modulating valves for variable flow service.
- Staff have indicated that some of the coils and valves are leaky and/or not functional. Valves have leaked and stained ceilings resulting in the need for ceiling repairs.

- Level 1
 - Existing functional VAV boxes will remain and should be rebalanced if needed.
 - Replace all VAV boxes that are nonfunctional or have leaky coils or valves.
 - Provide additional VAV boxes where more temperature control is needed.
- Level 2
 - Remove all VAV boxes, piping, ductwork, and accessories.
 - Provide new air-cooled heat pump fan coil units for each temperature control zone currently served by VAV boxes.
 - Any salvageable existing ductwork to remain and be cleaned.
 - New DDC controls shall be compatible with campus wide control system.
- Level 3
 - Remove all VAV boxes, piping, ductwork, and accessories.
 - Provide new water-cooled heat pump fan coil units for each temperature control zone currently served by VAV boxes.
 - Any salvageable existing ductwork to remain and be cleaned.
 - New DDC controls shall be compatible with campus wide control system.

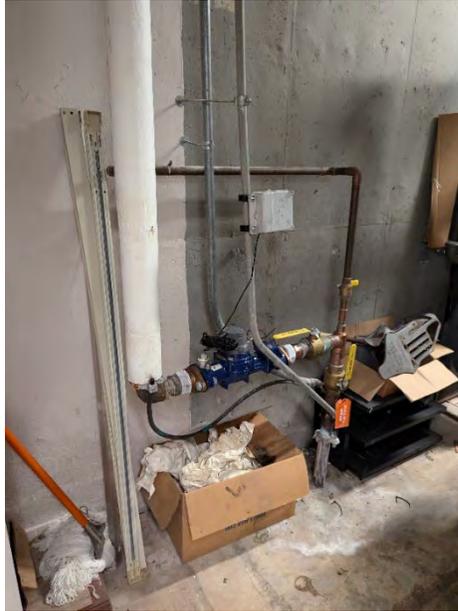
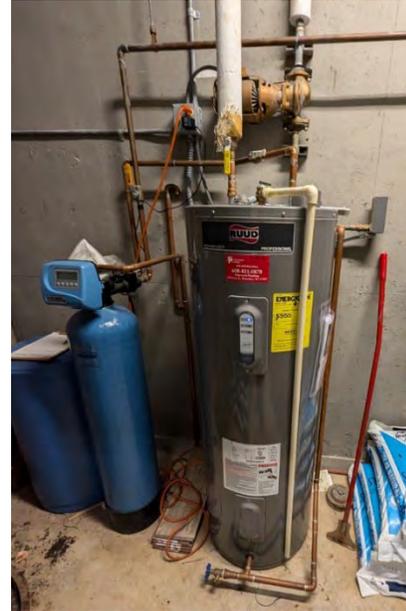
- The domestic water and sanitary drain waste and vent systems appear to be in satisfactory condition with no major issues. The water heater was replaced in 2016 and the sump pump was replaced in 2023.

- The water heater will need replacement in the next 5-10 years. It is recommended that the replacement be a hybrid electric heat pump water heater, providing higher efficiency but at a higher upfront cost compared to a traditional electric resistive water heater.
- The building needs a set of ADA restrooms. ADA plumbing fixtures will be required when this renovation occurs.
- Replacing traditional urinals with waterless urinals can help reduce overall domestic water consumption as well as reduce the amount of wastewater leaving the building.
- To further reduce water consumption, a rain capture system can be installed to catch, treat, and store water. This non-potable water can be used in lieu of domestic water for supply to water closets in the building.
- Provide additional electric water coolers with bottle fillers.

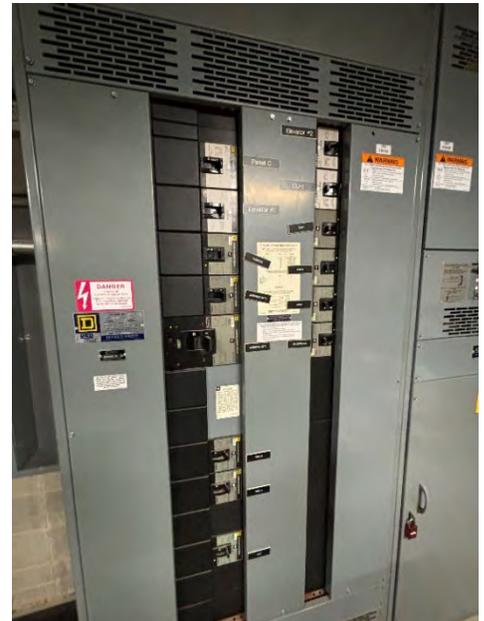
- Electrical service switchboard is original to the 1989 building and in good-to-fair condition. Mix of legacy and modern breakers. Modern breakers are readily available in event of failure or upgrades. Remaining useful life 5-10 years if properly maintained.

- Panelboards A & B are original to building and in good-to-fair condition. A mix of legacy and modern breakers are present. Modern replacement breakers readily available. Nearly all circuits are in use. Limited expansion available within existing panelboards. Remaining useful life 10-15 years if properly maintained.

- Panelboard C was installed as part of a 2003 remodel project. Panelboard is of modern design, installed in a clean, temperature-controlled environment, and 29 spare circuits. Remaining useful life is 15-25 years

- The electrical disconnects and starters supporting legacy HVAC equipment are in fair condition and nearing the end of useful life.

- If aging HVAC equipment is replaced in-kind, the electrical disconnects and starters should be opportunistically replaced.
- Additional load from electrification of HVAC or adding solar PV generation will not require replacement of the main switchboard but should be evaluated to be an opportunistic replacement as part of larger projects.
- When main switchboard is replaced, evaluate if reducing the size from 1200A to 1000A or 800A due to low utilization.
- Replacement of Panelboards A & B should be planned to be included as part of larger projects for modernization and expansion of capacity.
- As the main switchboard and panelboards are replaced, determine the best location for potential solar PV generation tie in points. Solar PV influences the required ratings of electrical power distribution equipment.

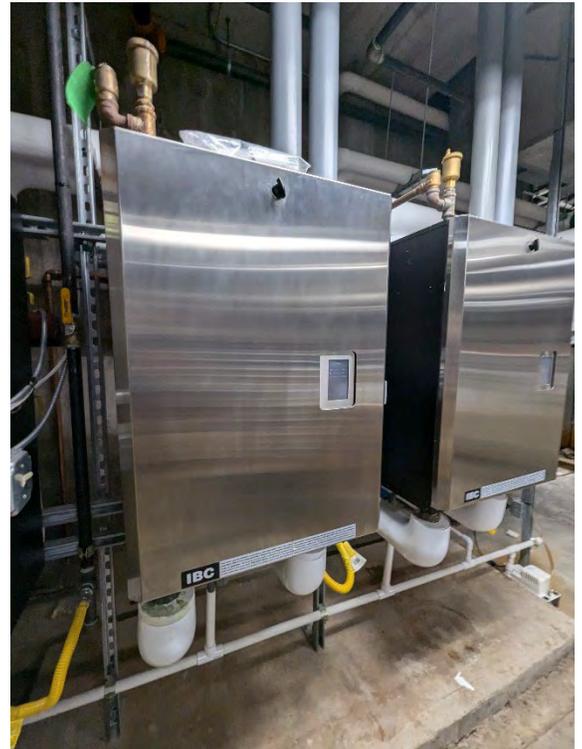
- Boilers appears to be in good condition and are approximately halfway through their expected service life.
- Some of the boilers appear to have had the heat exchangers replaced.

- Level 1
 - Existing boilers, pumps, and accessories to remain.
 - Repair/replace existing air-cooled condensing unit.
 - Repair/replace existing VAV boxes that are leaky or nonfunctional.
- Level 2
 - Remove boilers, associated pumps, controls and piping.
 - Provide new air-cooled heat pump air handling units to fully electrify the HVAC system, utilizing the PV Solar panels on site.
 - New DDC controls shall be compatible with campus wide control system.
- Level 3
 - Remove boilers, associated pumps, controls and piping.
 - Provide new geothermal vertical ground loop on site.
 - Provide new glycol pumps, piping, valves, accessories, and controls for new geothermal system.
 - New DDC controls shall be compatible with campus wide control system.

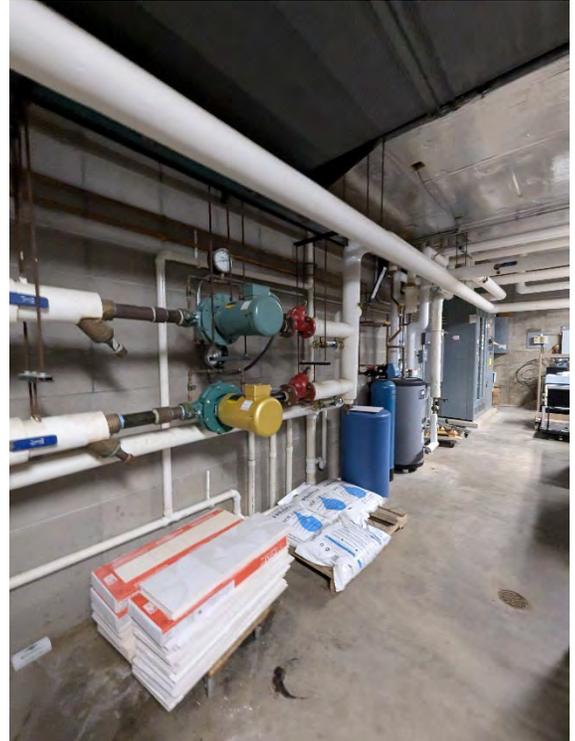
- System Pumps P-1 and P-2 appear to be in good condition.
- Boiler Pumps appear to be in good condition.
- Pumps do not include VFD modulating. System is configured for constant flow.

- Level 1
 - Existing pumps, and accessories to remain.
- Level 2
 - Remove boilers, associated pumps, controls and piping.
 - No hydronic pumps required for Level 2 recommendation (air cooled heat pumps)
- Level 3
 - Remove boilers, associated pumps, controls and piping.
 - Provide new geothermal vertical ground loop on site.
 - Provide new glycol pumps, piping, valves, accessories, and controls for new geothermal system.
 - New DDC controls shall be compatible with campus wide control system.

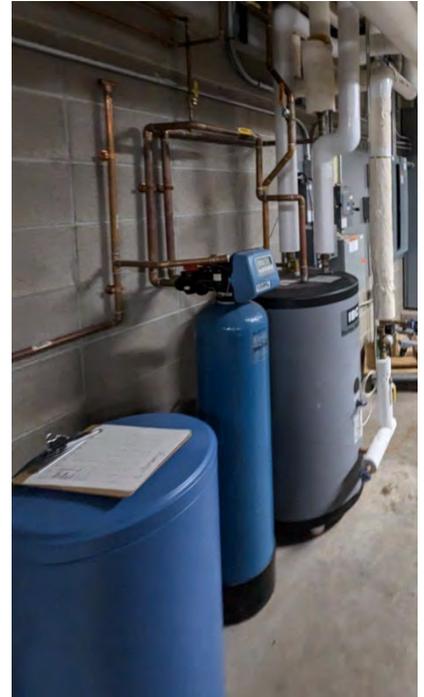
- The domestic water and sanitary drain waste and vent systems appear to be in satisfactory condition with no major issues. The indirect water heater was installed in 2015 and the sump pump was replaced in 2023.
- Staff have communicated low pressure issues with the existing domestic hot water system.

- If the existing hydronic heating hot water system is removed, it is recommended that the indirect water heater be replaced with a hybrid electric heat pump water heater, providing higher efficiency but at a higher upfront cost compared to a traditional electric resistive water heater.

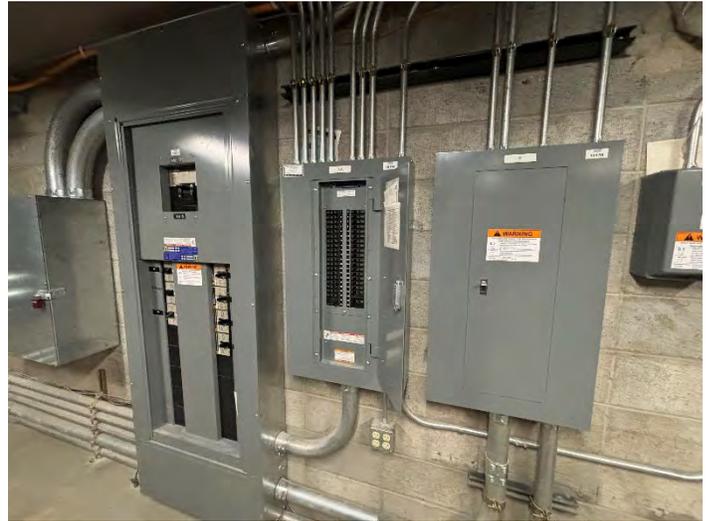
Overall, power distribution equipment is in very good condition.

- Main panelboard was installed around 2000 and is in good condition. Mix of legacy and modern breakers. Modern breakers are readily available in event of failure or upgrades. Remaining useful life 20-30 years if properly maintained.
- Panelboards were also installed around 2000 and in good condition. Modern replacement breakers readily available. Remaining useful life 20-30 years if properly maintained.

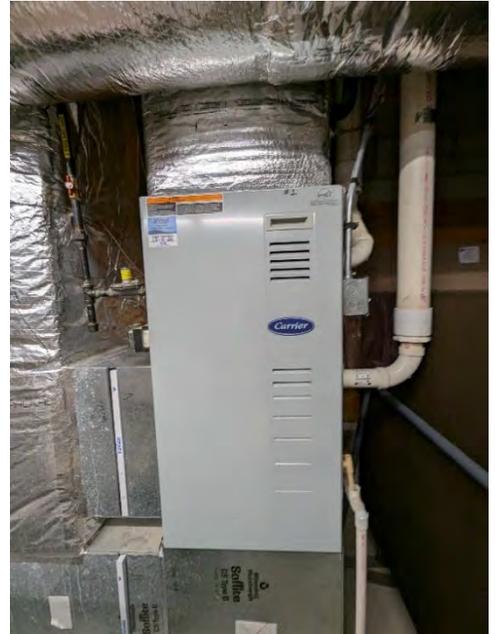
- Most of the furnaces are in good condition and have been replaced recently. Some of the furnaces are equipped with humidifiers and/or ionizing air purifiers.

- Level 1
 - Provide additional air cooled heat pumps providing additional zones to reduce over-cooling issues.
 - Replace existing exhaust fans and outside air ducts with energy recovery ventilators. This will allow for much more outside air to be delivered to the spaces while also recovering energy from the exhaust air.
 - Provide air purifiers for all air systems.
- Level 2
 - Remove all furnaces and air cooled condensing units.
 - Replace existing exhaust fans and outside air ducts with energy recovery ventilators. This will allow for much more outside air to be delivered to the spaces while also recovering energy from the exhaust air.
 - Provide new air-cooled heat pump air handling units to fully electrify the HVAC system, utilizing the PV Solar panels on site.
 - Provide air purifiers for all air systems.
 - New DDC controls shall be compatible with campus wide control system.

- Level 3
 - Remove all furnaces and air cooled condensing units.
 - Replace existing exhaust fans and outside air ducts with energy recovery ventilators. This will allow for much more outside air to be delivered to the spaces while also recovering energy from the exhaust air.
 - Provide new geothermal vertical ground loop on site.
 - Provide new water cooled heat pump air handling units to fully electrify the HVAC system, utilizing the PV Solar panels on site.
 - Provide air purifiers for all air systems.
 - New DDC controls shall be compatible with campus wide control system.

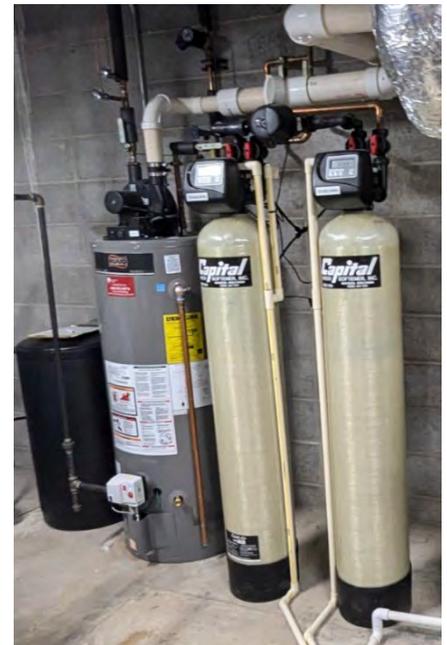
- The domestic water and sanitary drain waste and vent systems appear to be in satisfactory condition with no major issues. The water heater was replaced in 2018.
- Staff have communicated issues regarding sewage backups in the basement.

- The water heater will need replacement in the next 5-10 years. It is recommended that the replacement be a hybrid electric heat pump water heater, providing higher efficiency but at a higher upfront cost compared to a traditional electric resistive water heater.
- Replacing traditional urinals with waterless urinals can help reduce overall domestic water consumption as well as reduce the amount of wastewater leaving the building.
- To further reduce water consumption, a rain capture system can be installed to catch, treat, and store water. This non-potable water can be used in lieu of domestic water for supply to water closets in the building.
- Provide additional electric water coolers with bottle fillers.
- Provide a backwater valve on the sanitary piping exiting the building to prevent future sewage backups.
