# Pheasant Branch Corridor Restoration and Improvements Master Plan

Prepared for  
City of Middleton  
7426 Hubbard Avenue  
Middleton, WI 53562

Prepared by  
Cardno, Inc.  
6140 Cottonwood Dr., Suite A  
Fitchburg, WI 53719  
608 661 2955  
[www.cardno.com](http://www.cardno.com)

February, 2020

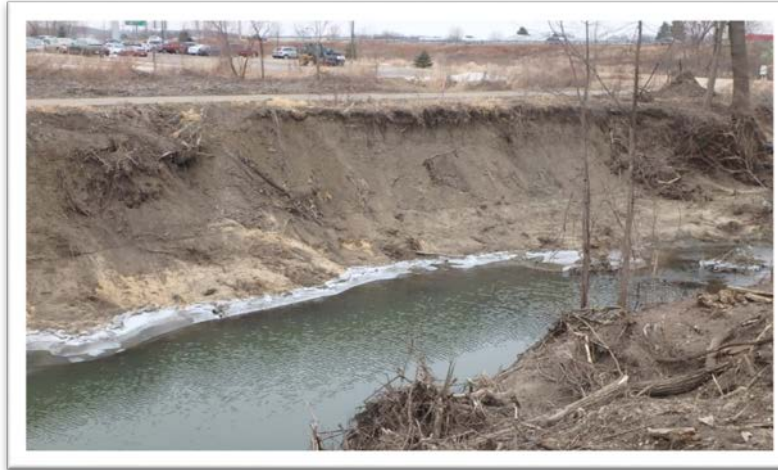
Some areas of the mainstem of Pheasant Branch between the confluence pond and Parmenter Street did experience various degrees of bank erosion following the August 2018 flood event. Streambank assessments within this area determined that approximately 1,520 linear feet of streambanks showed High bank erosion rates with an additional 197 linear feet exhibiting Very High and 264 linear feet of Extreme streambank erosion (Figure 10).

Figure 10: Extreme streambank erosion as a result of August 2018 flood event near Deming Way viewing downstream (1/15/19).

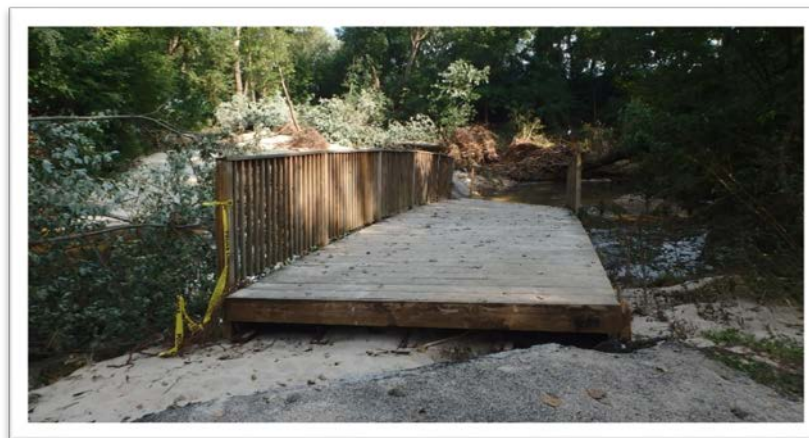
The mainstem of Pheasant Branch between Parmenter Street and Park Street experienced significant damage following the August 2018 flood event. All three pedestrian bridges that cross the channel between Parmenter Street and Park Street were damaged (Figure 11).

Figure 11: Photo of damaged bridge near Parmenter Street following August 2018 flood viewing downstream (8/25/18).

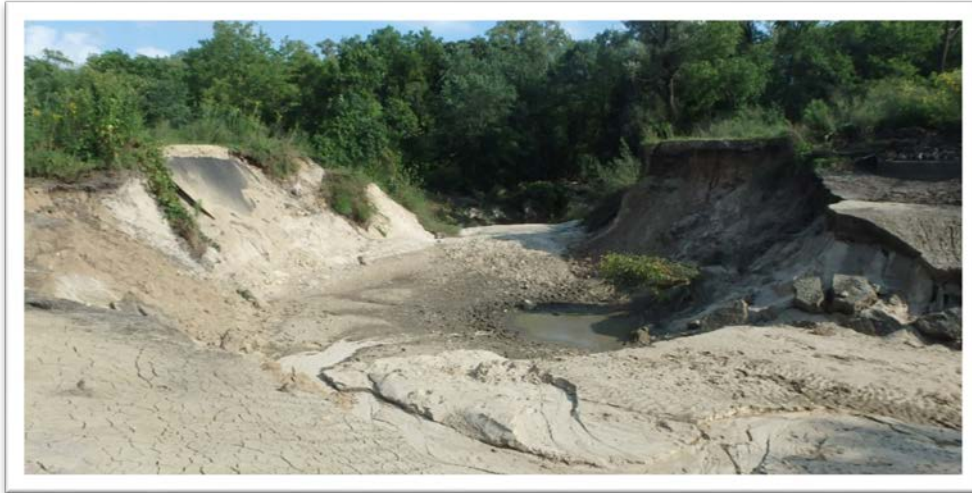
Extensive damage also occurred at the Donna Drive sedimentation pond where flood waters overtopped the pond, eroding the pond bank, causing a complete failure of the pond and stream embankment (Figure 12).

**Figure 12: Photo of Donna Dr. sedimentation pond failure following August 2018 flood event (8/25/18).**

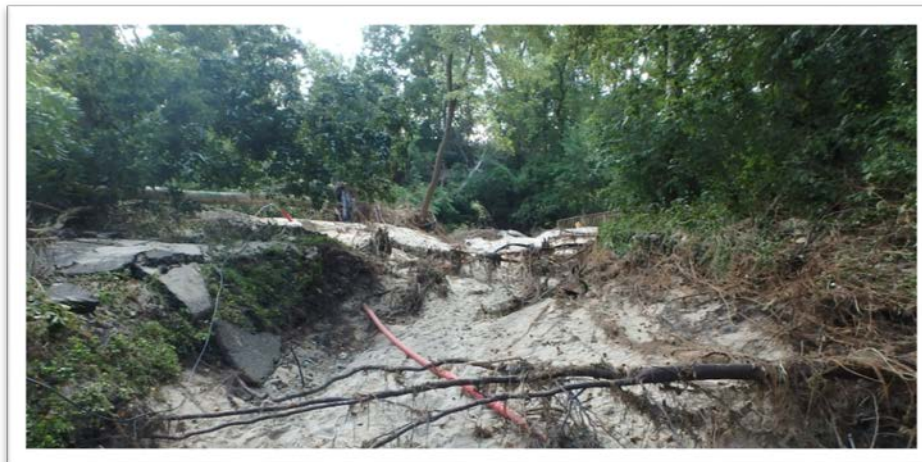
Much of the damage to the existing bridges and streambanks in this section was caused by debris jams consisting of mainly shallow rooted tree species that collapsed into the stream during the August 2018 flood event. Streambank assessments performed through this reach identified approximately 3,892 linear feet of streambanks showing evidence of High bank erosion with 453 linear feet of Very High and 625 linear feet of Extreme streambank erosion. Much of the pedestrian trail system adjacent to Pheasant Branch was also damaged during the August 2018 flood event. These areas will also need to be repaired along with restoration of streambanks and the stream channel in this section of Pheasant Branch (Figure 13).

**Figure 13: Photo of pedestrian trail damage between Parmenter Street and Park Street following August 2018 flood event (8/25/18).**

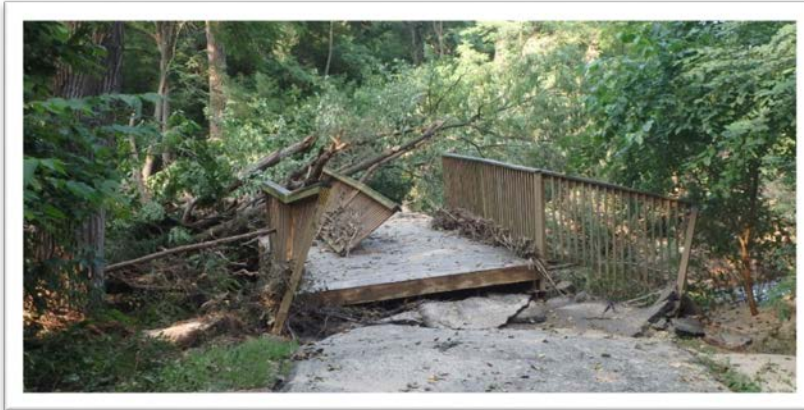
The mainstem of Pheasant Branch between Park Street and Century Avenue experienced significant damage during the August 2018 flood event including damage to each of the three pedestrian bridges located in this section of stream (Figure 14).

**Figure 14: Photo of damaged pedestrian bridge between Park Street and Century Avenue following August 2018 flood event (8/25/18).**

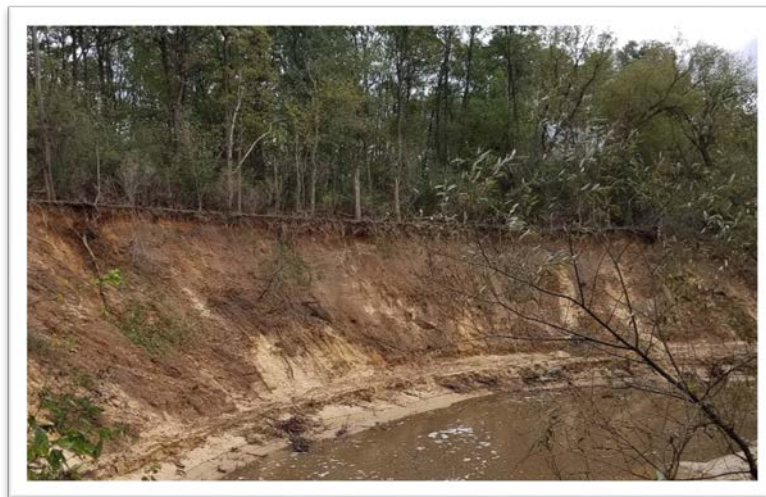
The public trail system within this section was also damaged and well as multiple areas of significant streambank erosion. Streambank erosion assessments within this reach found that approximately 2,289 linear feet of streambank showed evidence of High bank erosion with 503 linear feet of Very High and 444 linear feet showing evidence of Extreme streambank erosion. Much of the damage to bridges and streambanks in this section was caused by debris dams comprised of shallow rooted trees that collapsed into the channel during the August 2018 flood event. Extreme streambank erosion also occurred directly downstream of the Park Street crossing as flood flows were concentrated through the culverts running beneath the roadway (Figure 15).

**Figure 15: Photo of extreme streambank erosion directly downstream of Park Street as a result of August 2018 flood event (10/11/18).**

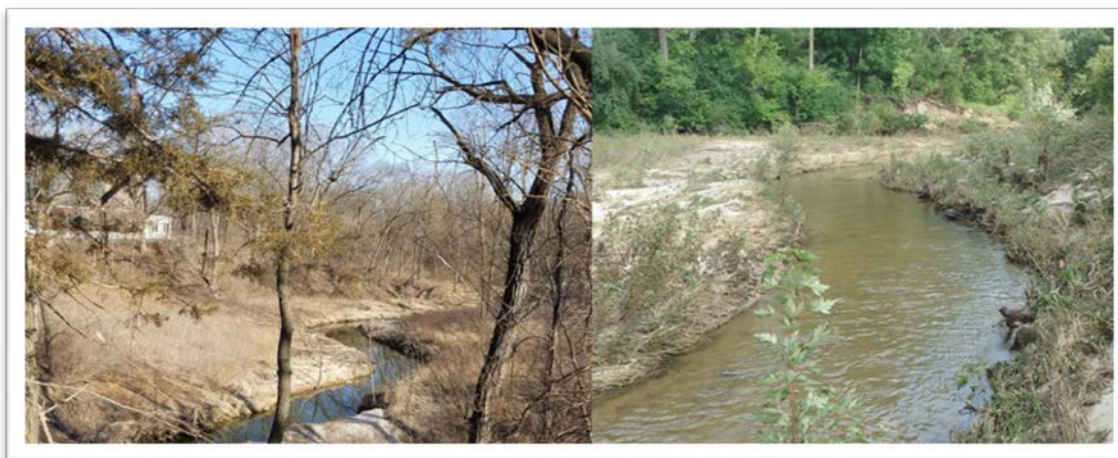
**Figure 65: Photo of relocated section of Pheasant Branch in 2017 (left) and same section of stream less than a week after flooding taken on 8/25/18 (right).**

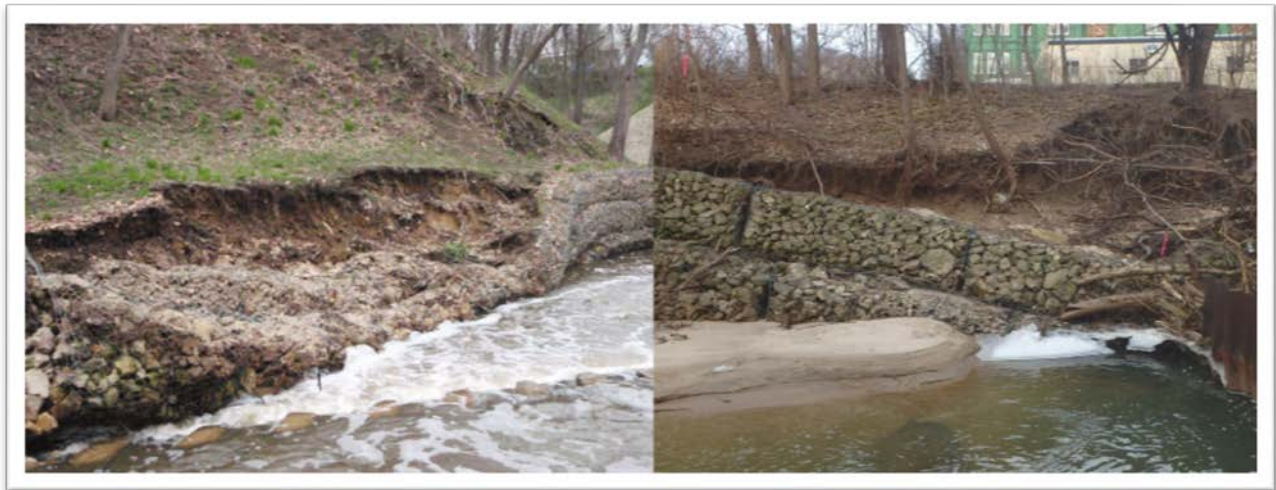
**Figure 66: Photo of failed gabion baskets between Park Street and Century Ave taken in 2008 (left) and directly downstream of Century Ave taken in 2018 (right).**

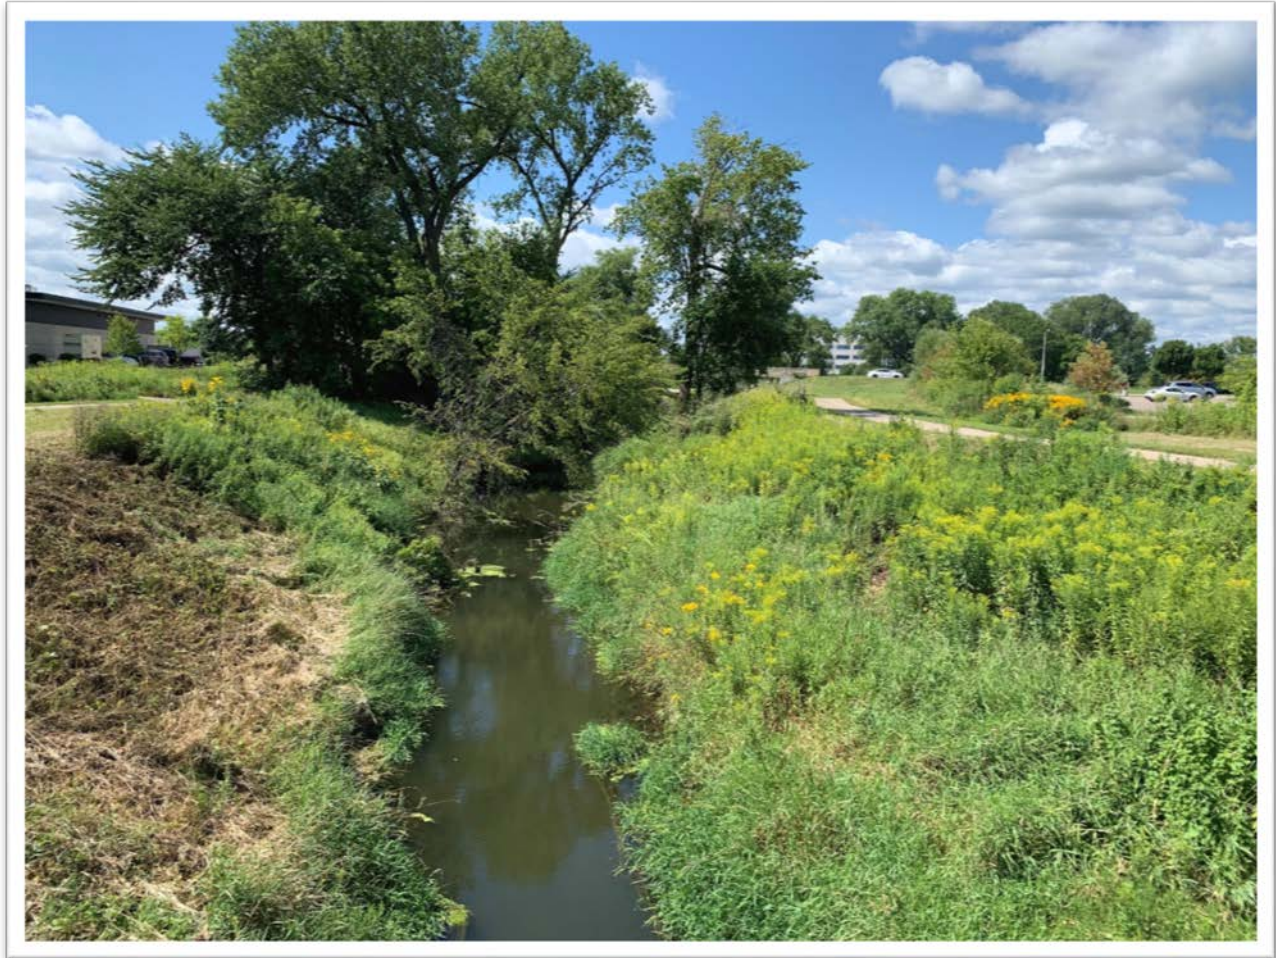
**Figure 69: Vegetation typical of the section between Deming Way and Parmenter Street.**  
This channelized section is dominated by invasive herbaceous plants and shallow rooted trees such as silver maple and box elder.

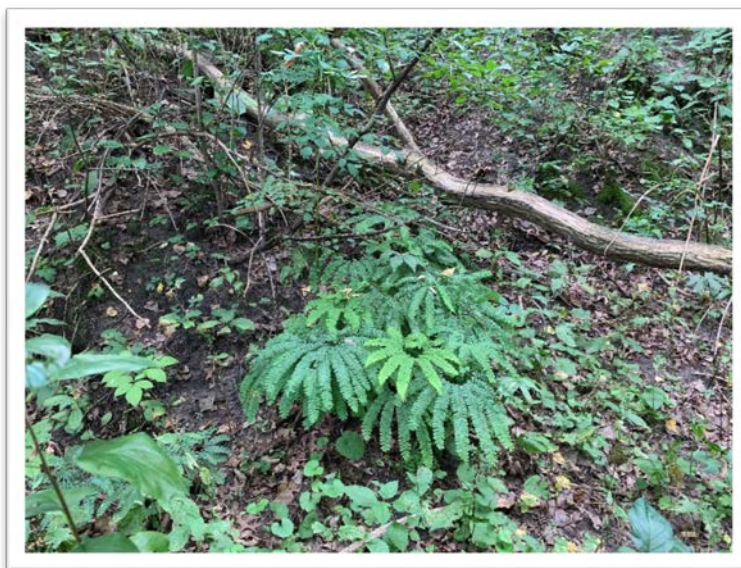
**Figure 74: Alternate-leaved dogwood growing in the corridor, getting overtaken by invasive shrubs.**

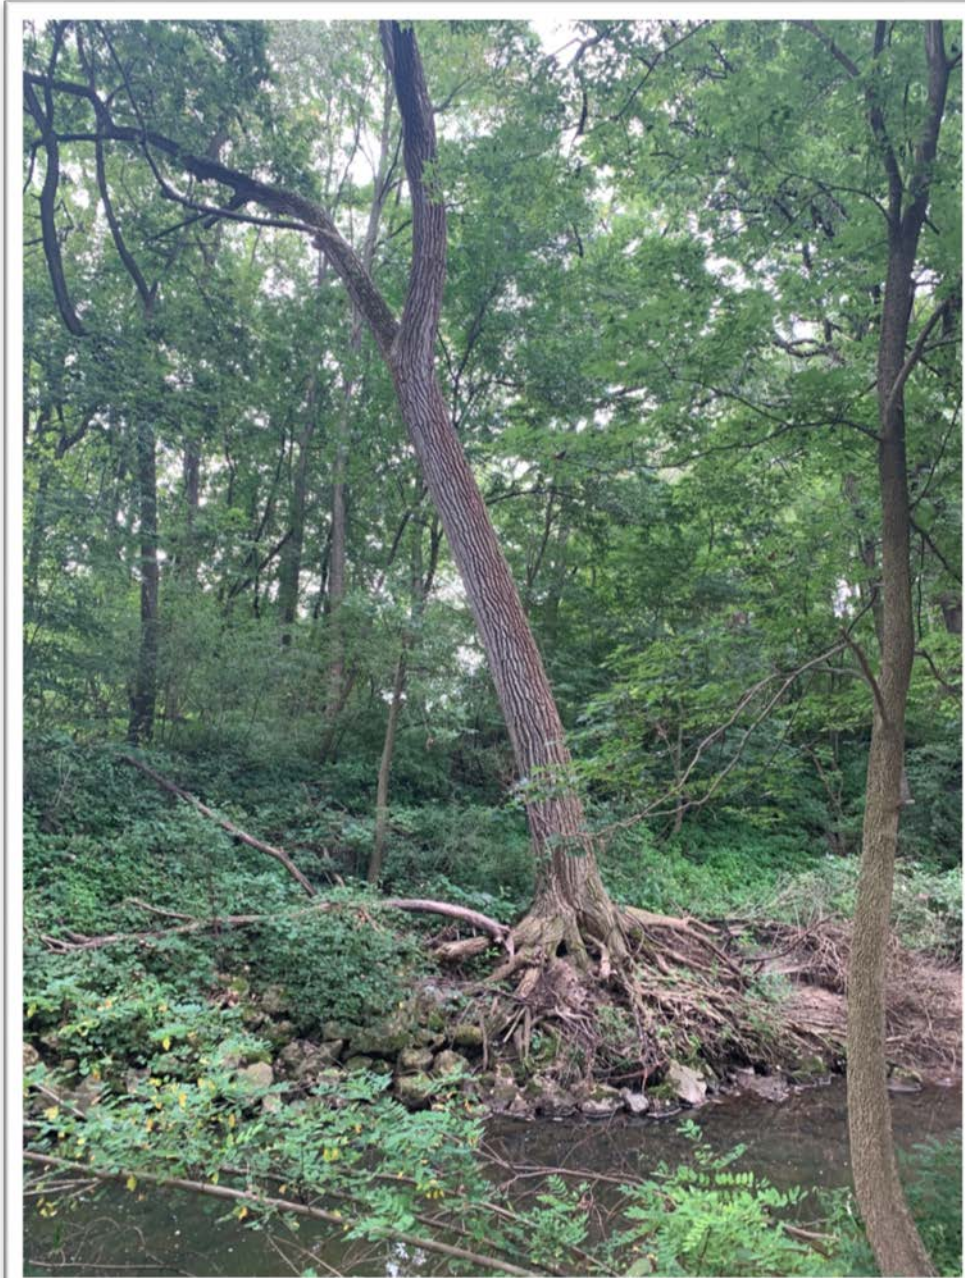
**Figure 79:** Example of a compromised tree that will eventually fall into the stream and potentially become hazardous debris during a flood event. Clearing some trees from the corridor will reduce the damage caused by debris in high flows
