# Middleton's Stormwater Management Program

A study on the effects of climate change and urbanization in the area

BY WARREN GEBERT

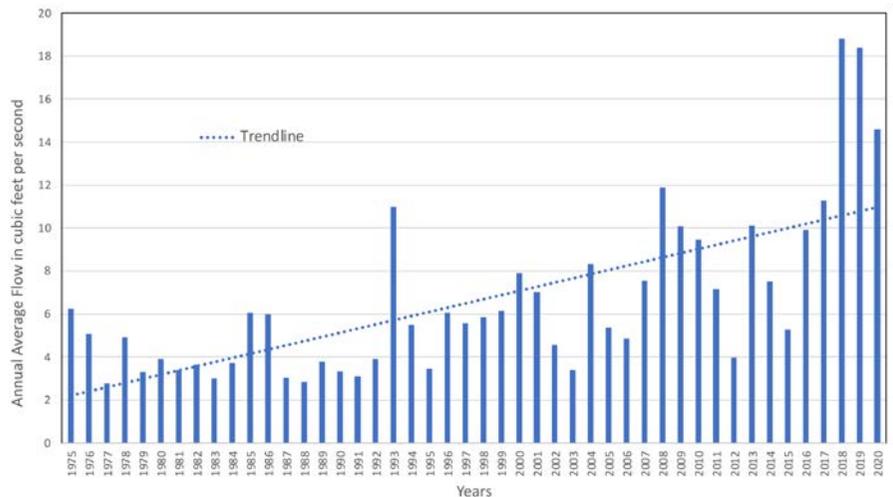
Figure 1. Annual average flow at Pheasant Branch at Parmenter Street for the period 1975-2020.

Over the 46-year period, streamflow characteristics have increased significantly at the mainstem Pheasant Branch's Parmenter Street gaging station. The large increases in annual average streamflow and annual flood peaks are shown in Fig. 1. This increase has a major impact on stormwater management practices and on the evaluation of the effectiveness of practices. The large increase is in part due to the increase in precipitation from climate change as well as rapid urbanization in the South Fork Pheasant Branch.

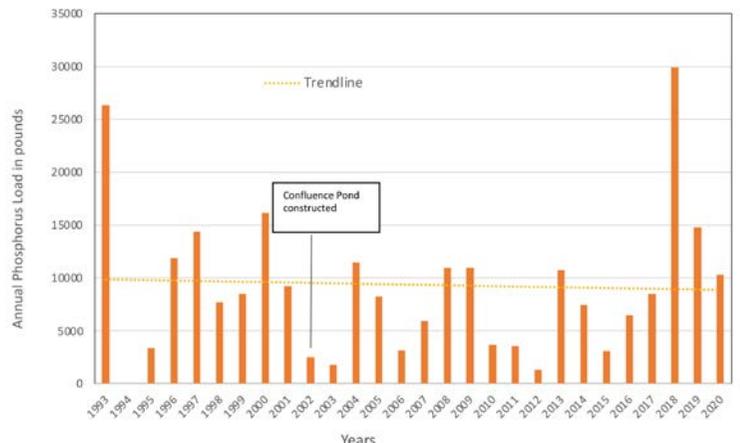
Figure 2. Annual phosphorus loads for Pheasant Branch at Parmenter Street for period 1993-2020.

In spite of the increased annual streamflow and flood peaks, the city's stormwater management practices have been successful in decreasing the sediment and phosphorus loads to Lake Mendota from Pheasant Branch. The decrease in annual phosphorus loads that were monitored at the Pheasant Branch Parmenter Street gaging station from 1993-2020, and shown in Fig. 2.

The biggest decrease in sediment and phosphorus loads occurred after 2002, when the Confluence Pond facility began its operation. Since then, the annual sediment load average observed has decreased from 2,300 tons per year to 1,000 tons per year for a decrease of 56 percent. The annual phosphorus load average has decreased from 12,200 pounds per year
