MEP Conditions Assessment - DRAFT

City of Middleton

MIDDC 179714 | September 23, 2024

Conditions Assessment - DRAFT

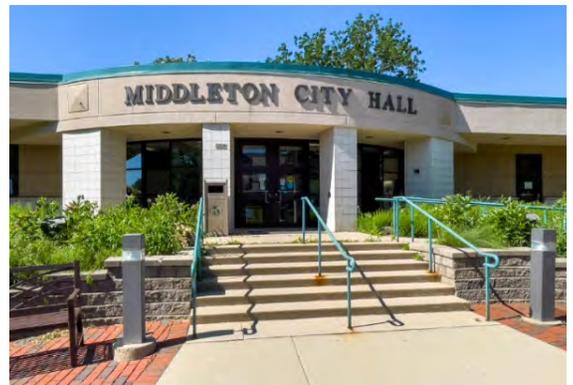
In general, much HVAC equipment is past its expected service life and is in fair or poor condition. The boilers, pumps, and some newer equipment was found to be in satisfactory condition. All recommendations contained in the report will be designed to meet current Wisconsin Energy Code and will be sized according to the existing building function.

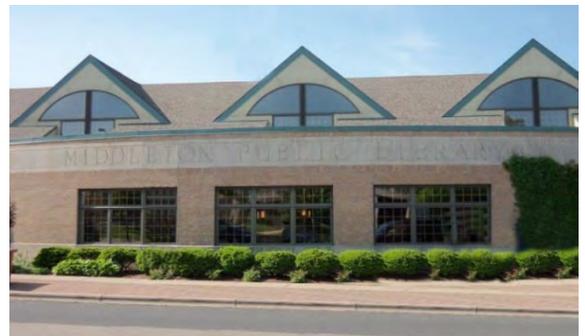
In general, much HVAC equipment is past its expected service life and is in fair or poor condition. The boilers, pumps, and some newer equipment was found to be in satisfactory condition. All recommendations contained in the report will be designed to meet current Wisconsin Energy Code and will be sized according to the existing building function.
