# Pheasant Branch Corridor Restoration and Improvements Master Plan

Prepared for  
City of Middleton  
7426 Hubbard Avenue  
Middleton, WI 53562

Prepared by  
Cardno, Inc.  
6140 Cottonwood Dr., Suite A  
Fitchburg, WI 53719  
608 661 2955  
[www.cardno.com](http://www.cardno.com)

February, 2020

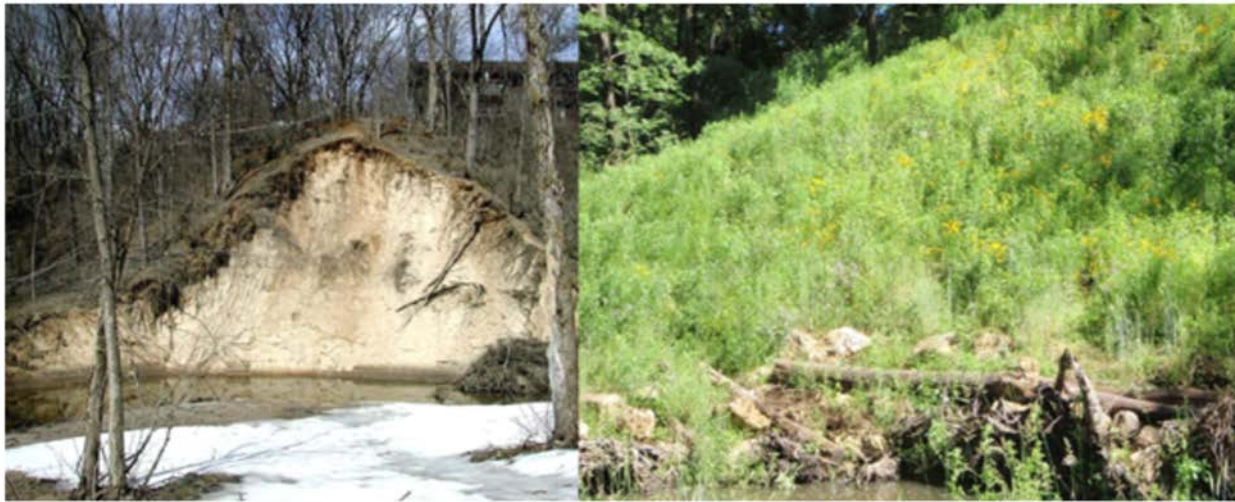
Figure 2: Photo of eroded slope adjacent to Pheasant Branch between Park Street and Century Avenue in 2005 (left) and same slope after construction taken in 2009 (right).

From 2007 to 2010, the City of Middleton performed approximately 2,000 linear feet of streambank and slope stabilization using ecologically-sensitive techniques including rootwad composites to protect the toe of the slopes and create additional deep pool and under-bank habitat. Slope grading was also performed on these slopes to bring them to a more stable angle and once completed the entire project areas were seeded with a mixture of native forbs and grasses. The dense growth and deep root systems of the native vegetation help to hold bank materials in place while allowing water to infiltrate through the soil instead of flowing overland to the stream (Figure 2).

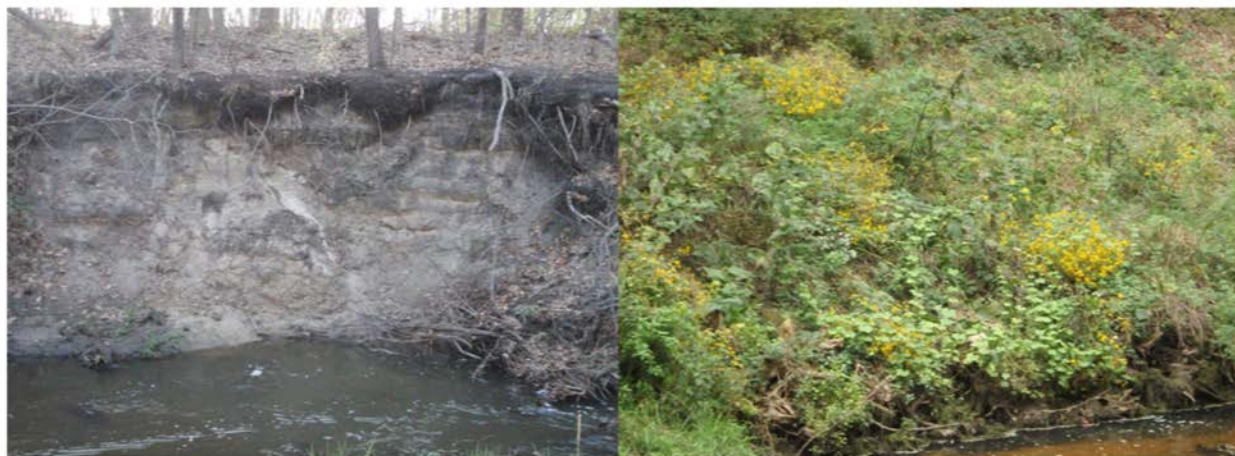
Figure 3: Photo of eroded slope adjacent to Pheasant Branch between Park Street and Parmenter Street in 2010 (left) and same slope after construction taken in 2014 (right).

In 2012, the City of Middleton stabilized nearly 1,500 linear feet of streambanks and slopes between Park Street and Parmenter Street within the Pheasant Branch Corridor using ecologically-sensitive techniques to mitigate erosion. To reduce the sediment load in the creek, stream energy dissipation structures and integrated bank treatments, including rootwad and toewood composites, cross-vanes, and single arm vanes were installed. These methods stabilized the banks while providing improved habitat for the insects, amphibians, reptiles, and fish found within the creek and riparian corridor (Figure 3).

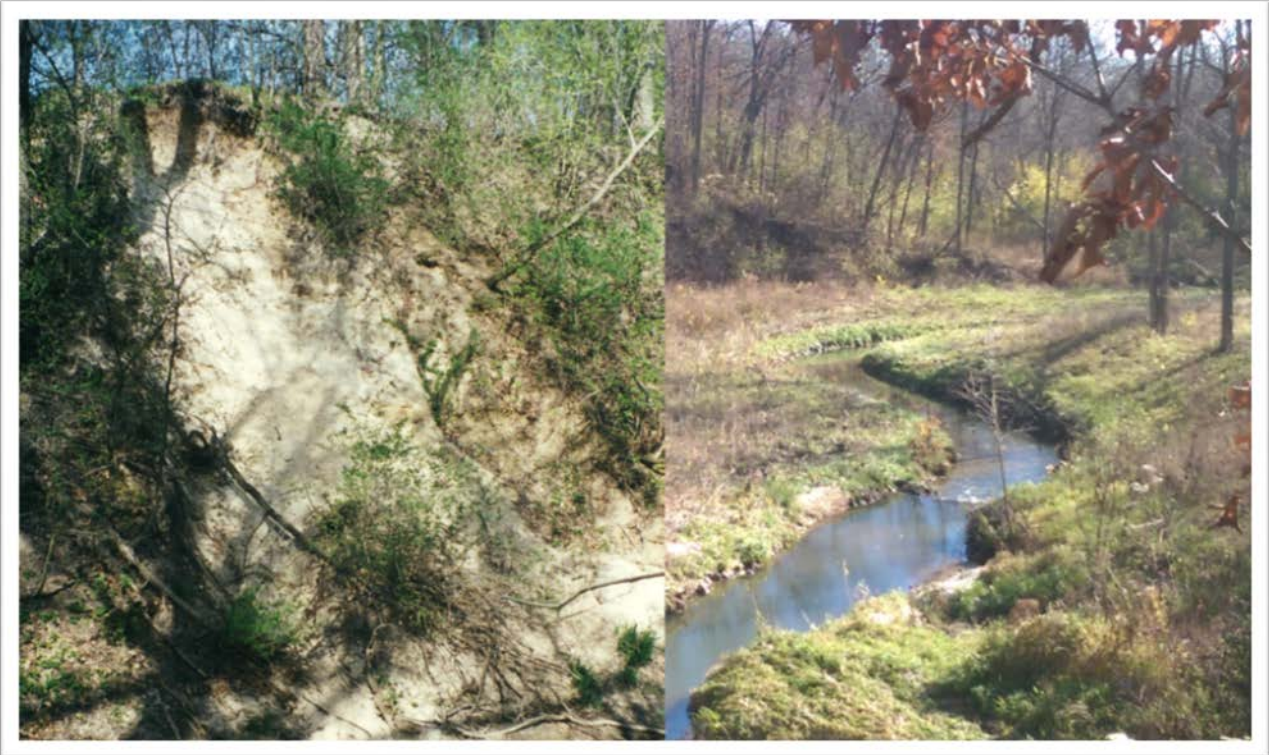
**Figure 4: Photo of collapsing streambank adjacent to Pheasant Branch near site of Kromrey Middle School addition 2013 (left) and same section of stream after construction taken in 2016 (right).**

The Pheasant Branch Kromrey Middle School Stream Relocation Project relocated approximately 500 linear feet of stream channel away from steep eroding slopes and streambanks by creating a new channel using ecologically-sensitive techniques to mitigate erosion. Relocation of this section of stream also increased flood flow capacity at the site allowing flood flows to rise up out of the bankfull channel and spread out over a newly created floodplain, dissipating energy, and offering increased protection at the toe of the steep slope above which a new addition to the Kromrey Middle School was built. As part of the project, an additional 0.04 acres of backwater oxbow wetland was created (Figure 4).

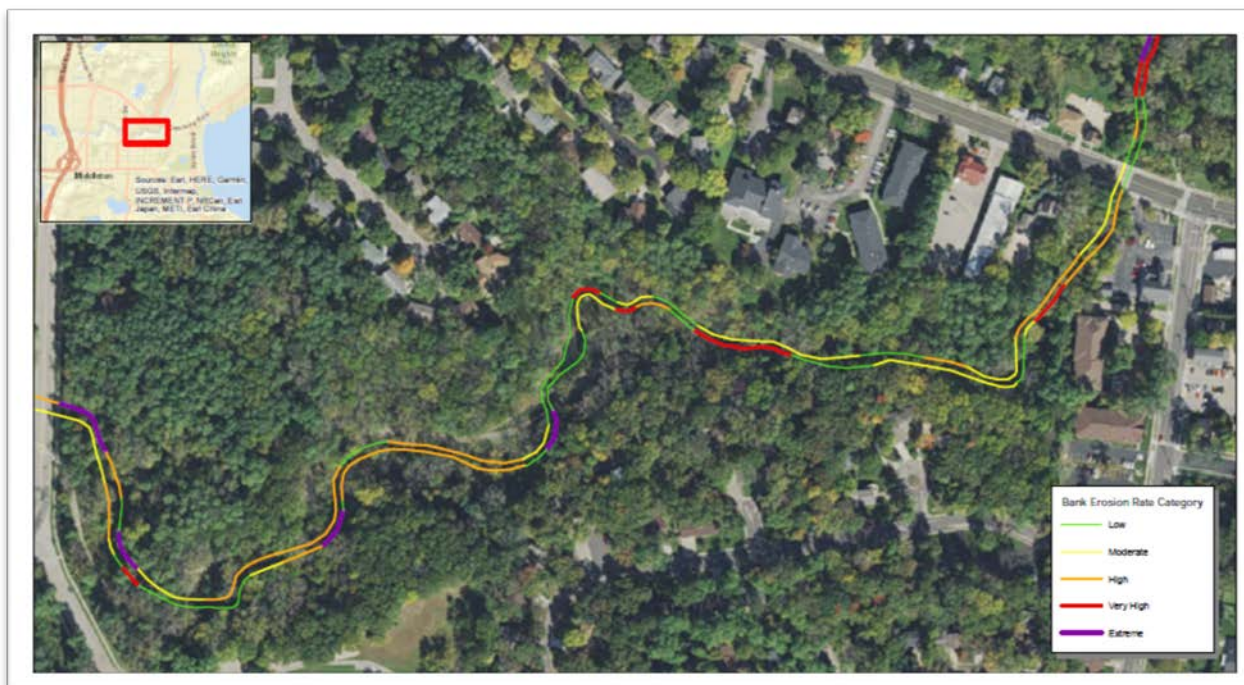
Cardno performed a complete streambank erosion assessment of both the left and right bank for the north fork, south fork and mainstem of Pheasant Branch. Streambank erosion assessments were performed using the Bank Erosion Hazard Index (BEHI) model developed by Dr. David Rosgen<sup>3</sup>. The BEHI model evaluates the susceptibility of a streambank to erosion for multiple erosional processes. Individual BEHI variables are recorded through visual assessments and physical measurements to determine the combined risk for specific streambank sections to future streambank erosion (Figure 9).

**Figure 9: BEHI model streambank erosion risk assessment for mainstem of Pheasant Branch between Park Street and Century Avenue**

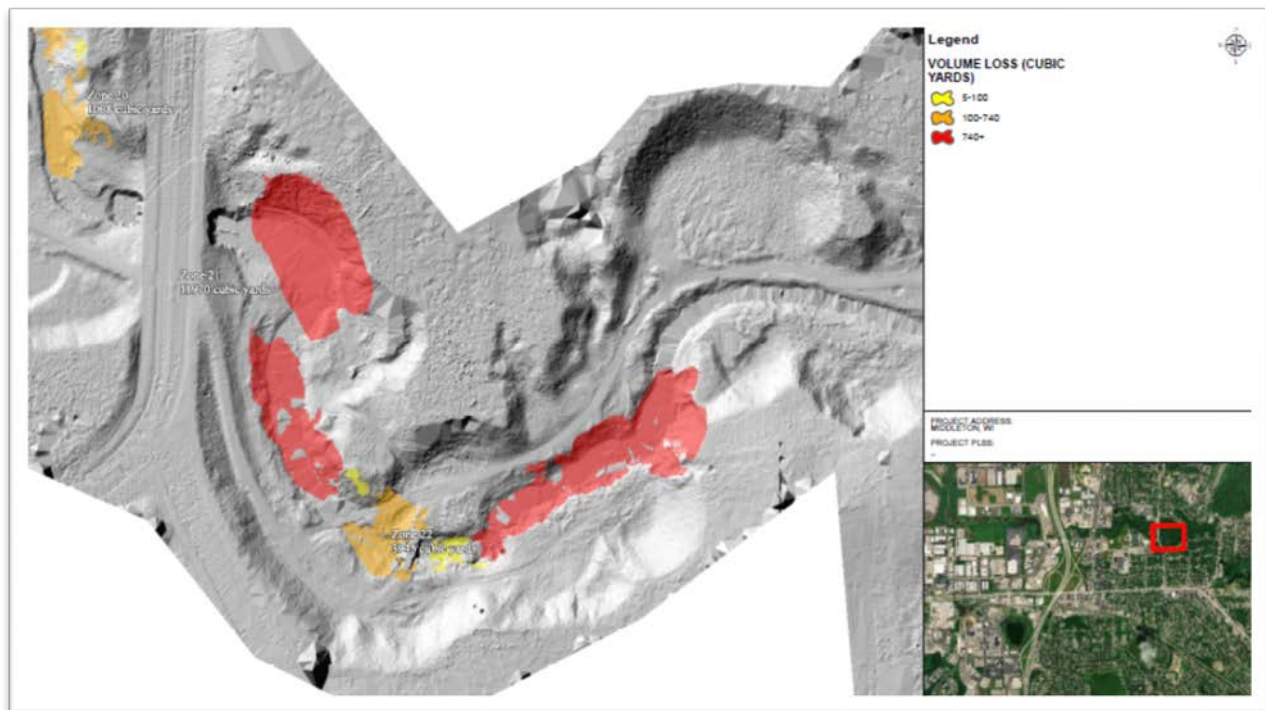
Figure 16: Example of comparison between 2017 and 2018 LiDAR data directly downstream of Park Street on the mainstem of Pheasant Branch.

Estimates of sediment loss throughout the Pheasant Branch Corridor total approximately 55,000 to 60,000 cubic yards of sediment lost from the channel and streambanks during the August 2018 flood event.

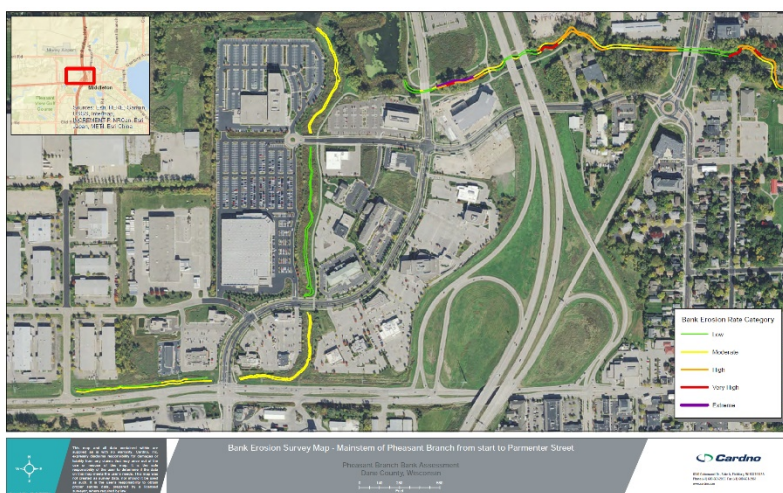
**Figure 59: Location of streambank restoration areas identified between the confluence Pond and Parmenter Street**

Restoration of the streambanks in the Pheasant Branch Corridor will focus on these areas as they pose a high risk to public and private property. Areas identified for restoration are shown in Figures (59, 60 and 61).

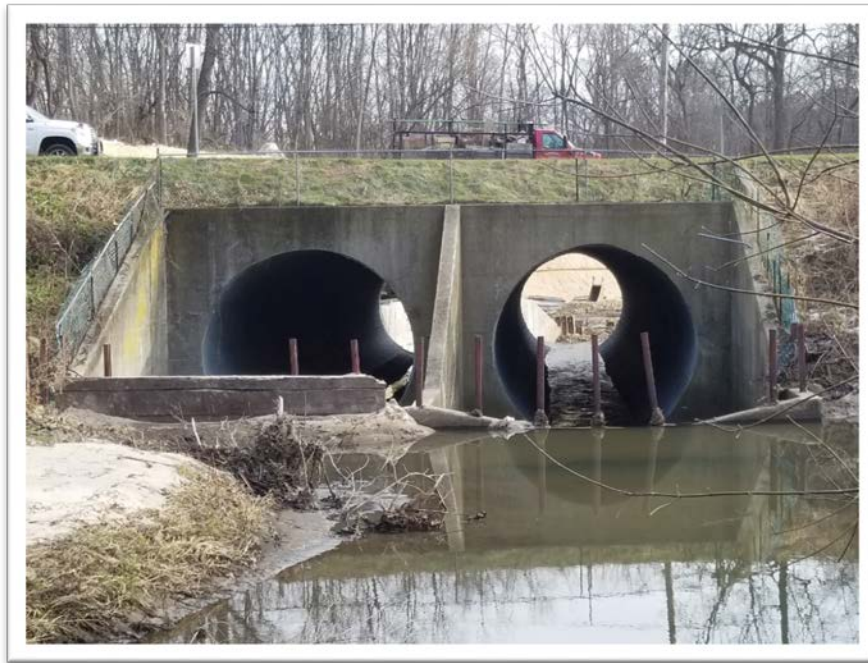
A drop structure and two large culverts at the stream crossing underneath Park Street currently act as a barrier to upstream migration of fish in the mainstem of Pheasant Branch. Retro-fitting with fish passage structures to aid fish passage over and through the current barrier or replacement of the current crossing with a bridge would eliminate this barrier (Figure 67). Replacement with a bridge would also increase flood flow capacity through this crossing which would need to be accounted for in designs. The existing drop structure also currently provides grade control at this location. Installation of grade control structures that still provide fish passage would also be necessary if the current structure was removed to mitigate destabilizing channel adjustments.

Figure 67: Photo of Park Street fish barrier

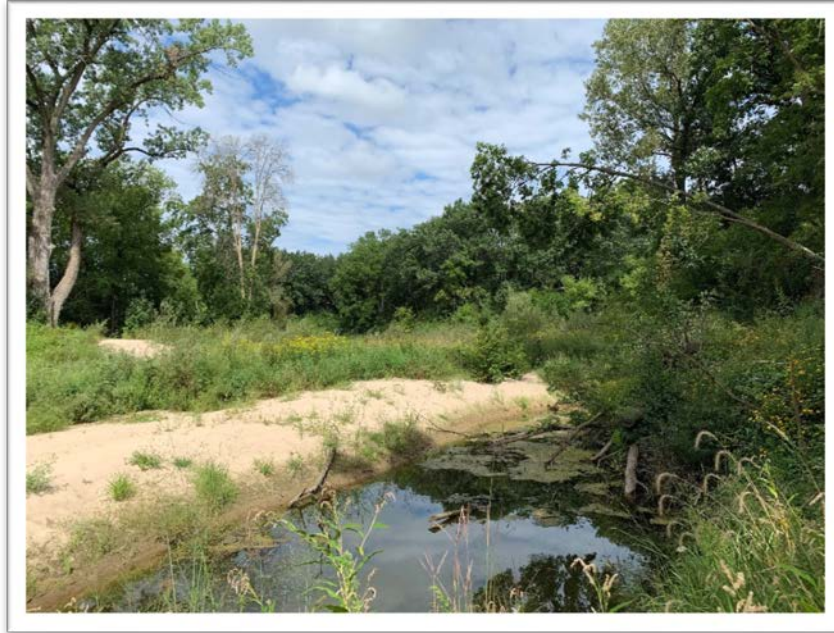
The sand prairie restoration is proposed for areas that received large deposits of sand from the 2018 flood. In some areas, several feet of sand were deposited on the existing vegetation (Figure 70).

**Figure 70: Areas of significant sand deposition by the 2018 flood. Rather than remove the sand, these are excellent opportunities for restoration of sand prairie and other sand-dependent ecosystems within the corridor.**

Rather than remove the sand, these are excellent opportunities for restoration of sand prairie and other sand-dependent ecosystems within the corridor. Because clearing is proposed and these areas will rarely be inundated, it is appropriate to propose a sand prairie restoration here. Restoration would consist of clearing the invasive vegetation and re-seeding with sand prairie and sand-dependent species (Figure 71).

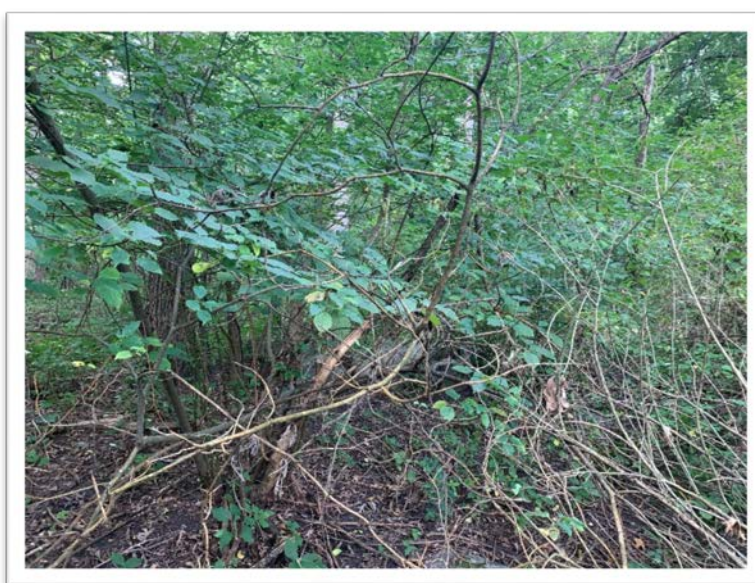
**Figure 75: Photo of invasive shrubs within the Pheasant Branch Corridor**

Clearing and managing of invasive species would be the main restoration action required here. With adaptive management of invasive species, we would hope to stimulate the native species already present (Figure 75).

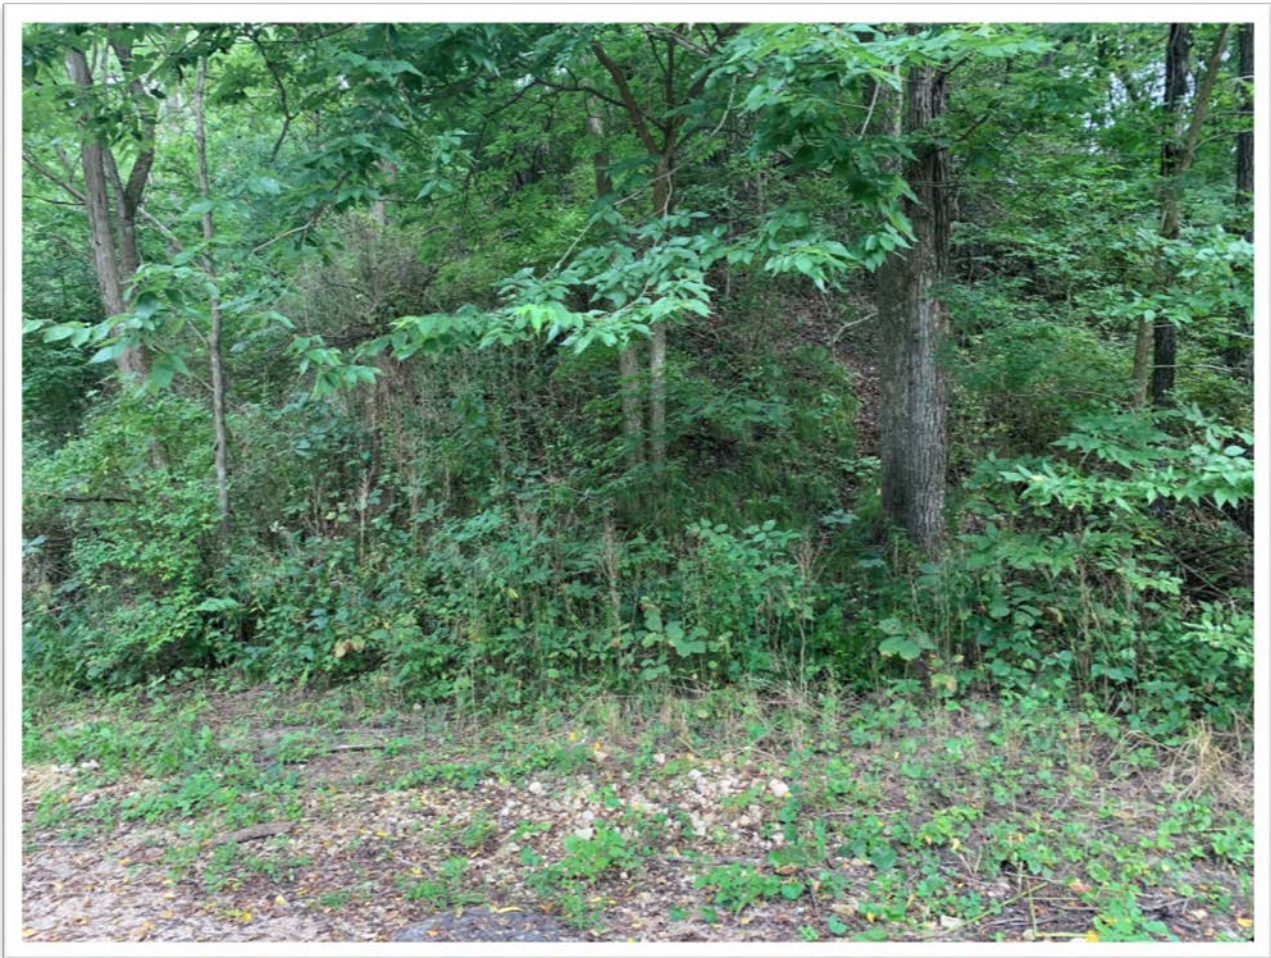
There are many canopy oak trees with large infestations of invasive trees and shrubs underneath them. There is very little sunlight reaching the ground in these areas, preventing oak regeneration and lowering overall diversity. This also exacerbates erosion as there is very little groundcover at all underneath the canopy.

**Figure 77: Overgrown knoll with large over story oaks that would be an ideal candidate for oak savanna restoration in the Pheasant Branch Corridor.**

Restoration would entail clearing invasive trees and shrubs to allow sunlight to reach the ground to stimulate the herbaceous understory and oak regeneration. Herbaceous invasive species such as garlic mustard and dame's rocket will also need to be controlled as part of this restoration area. Re-seeding would also be proposed to increase herbaceous diversity. These areas could be managed by prescribed fire to control woody invasive species and stimulate native herbaceous cover (Figure 77).

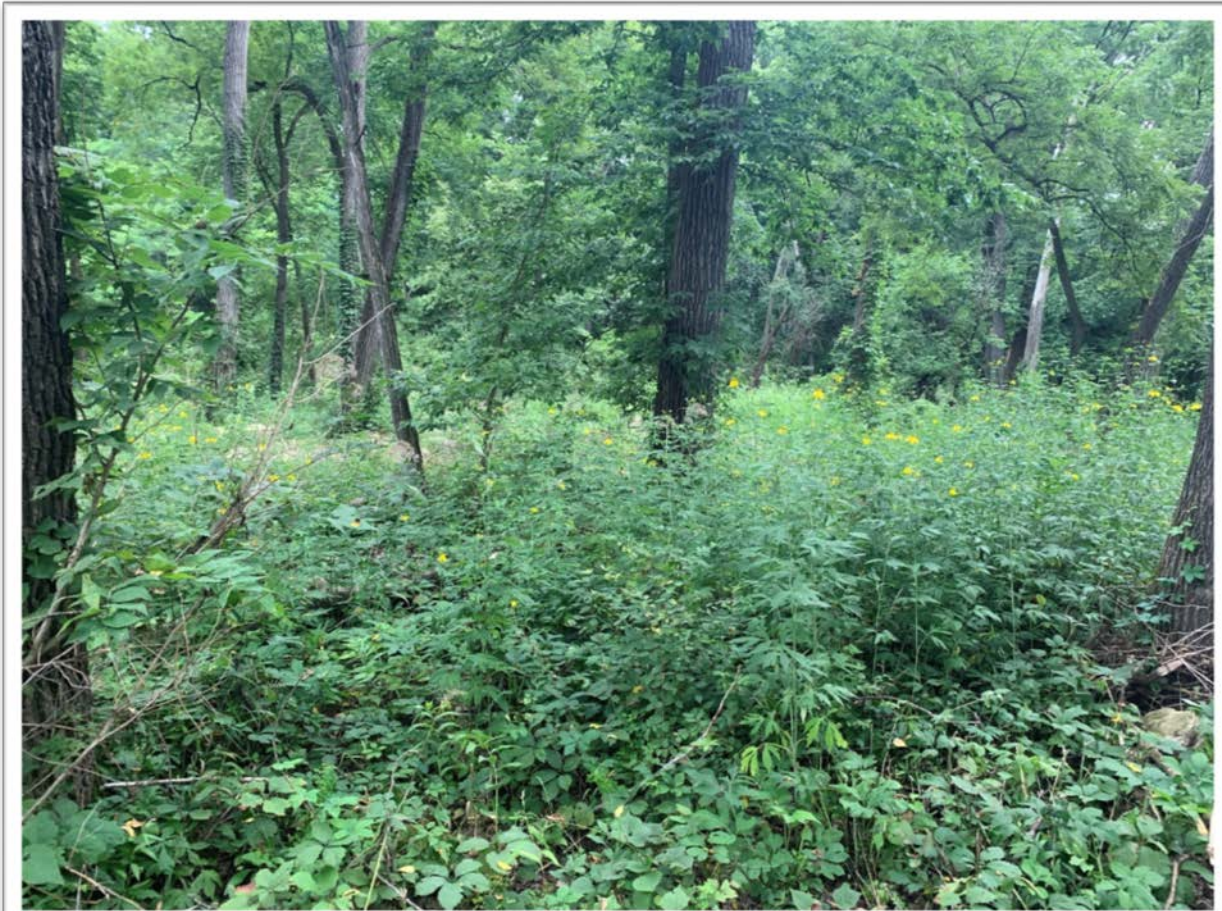
The floodplain restoration refers to the wooded areas directly abutting the creek within the existing floodplain. These areas experienced severe erosion and tree loss during the 2018 flood. This area is currently dominated by large canopy trees such as black walnut, cottonwood and silver maple along with invasive trees like black locust (Figure 78).

**Figure 78: Native herbaceous floodplain vegetation thriving where some sunlight can reach the ground. Further clearing along with re-seeding and other restoration would stimulate regeneration of native herbs**

Clearing trees (especially invasive species such as black locust) will be necessary to aid in stormwater conveyance but will also provide an opportunity to restore the native herbaceous community, shrub layer and stimulate oak regeneration. Herbaceous invasive species such as garlic mustard and dame's rocket will also need to be controlled as part of this restoration area (Figure 79).
